## Final UST REMOVAL REPORT

#### 117th REFUELING WING

#### 226th COMBAT INFORMATION SYSTEMS GROUP

January 1997

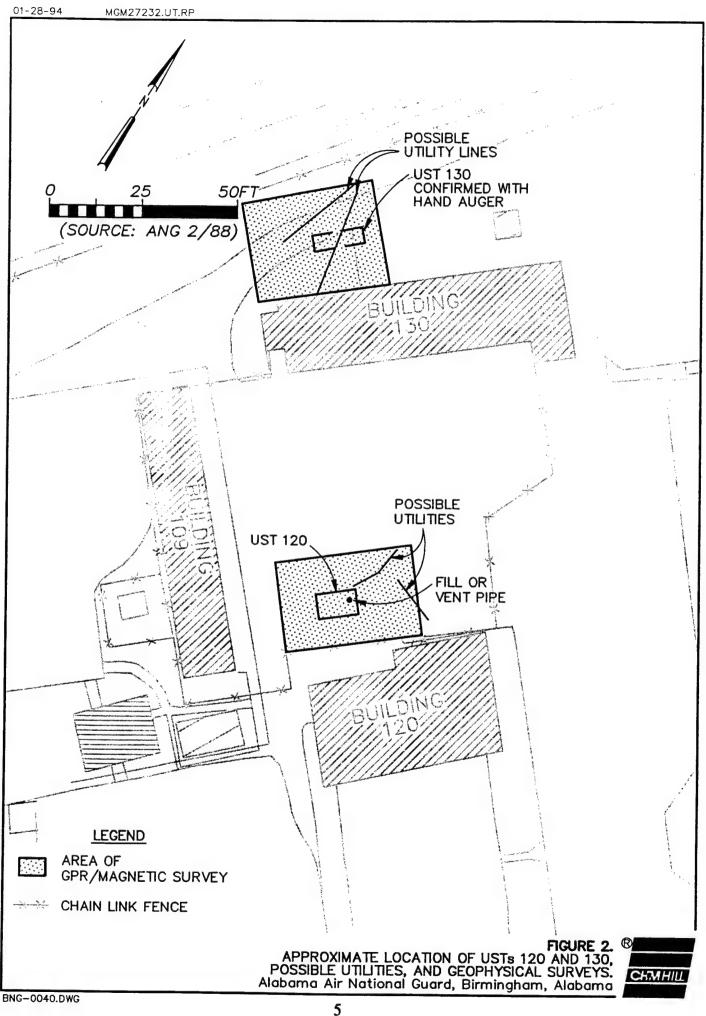
Figure 2 presents the results of the investigation at UST 120. An anomaly was identified in this study area. A 1½-inch vent line is present at the surface within the area overlying the subsurface anomaly. The tank pit area is approximately 6 ft x 4 ft, with the long axis parallel to and 8 ft north of the chain-link fence surrounding Building 120. Two apparent utility lines were located in the study area but did not extend into the tank pit. According to Base personnel, the major tower communications trunk passes 8-15 ft east of the tank. Samples were obtained of the liquid in the tank and results of those analyses are contained in Appendix B. The water samples were collected and analyzed for VOCs (EPA Method 601 and 602), total lead (EPA Method 239.2), Flashpoint (EPA Method 1010), and polynuclear aromatics (EPA 610). The results for UST 120 indicate that it contains an aqueous solution with dilute levels of lead, xylenes, fluorene and napthalenes, and the flashpoint indicates that it is ignitable. These results are indicative of diesel or fuel oil which has been diluted by water.

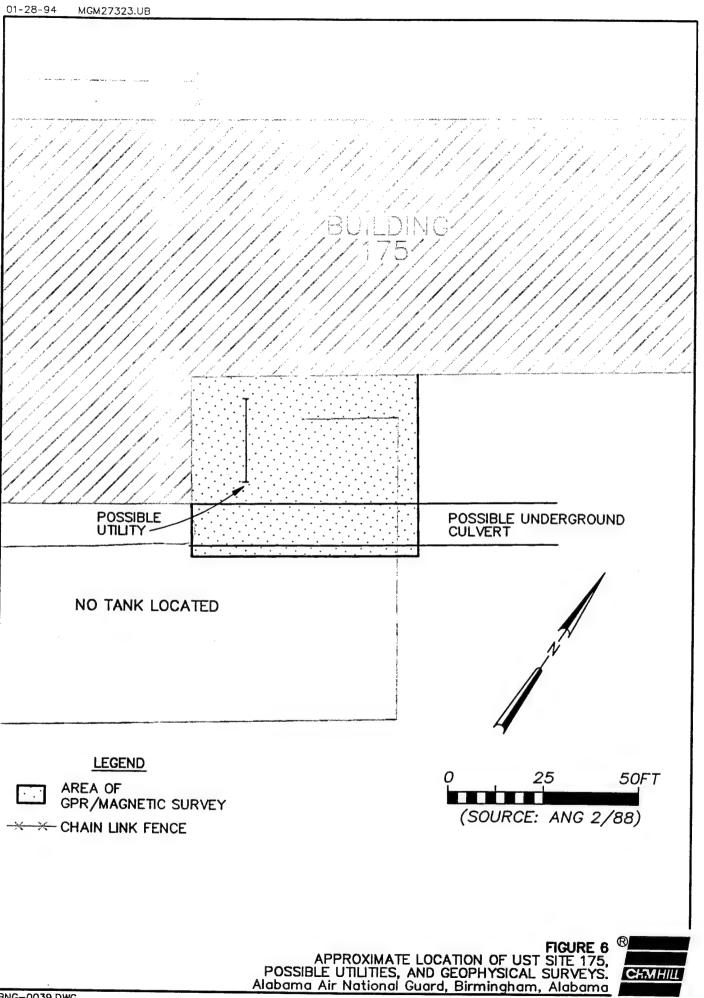
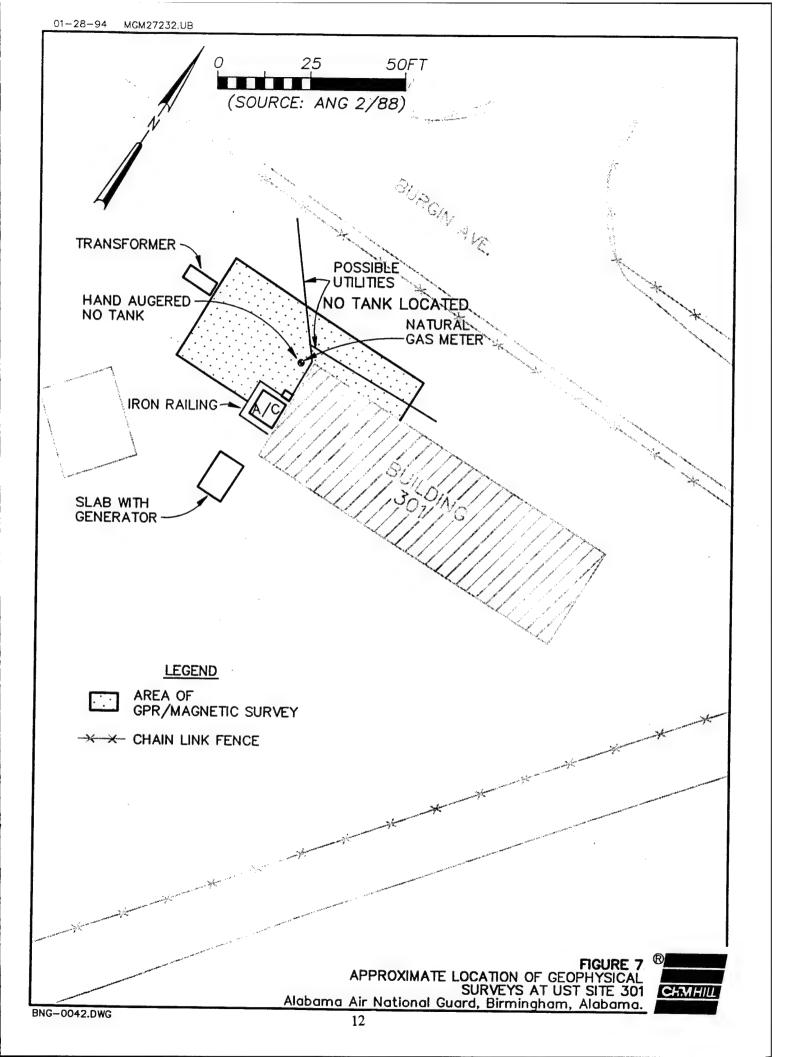
The suspected UST area around Building 175 is shown in Figure 6. This site was included in the study because of a raised area in the asphalt underlain by a concrete slab. No piping is visible and no information was available about the UST. GPR indicated an area of irregular slope that was interpreted as possible construction debris or abandoned, truncated utilities. The possible existence of the debris suggests that if there was a tank at this location, it was removed and the area backfilled. One former Base employee remembered an aboveground tank at this location. Because of the lack of specific recollections by base personnel of this tank and the information from the GPR report, no further investigation is recommended at this location.

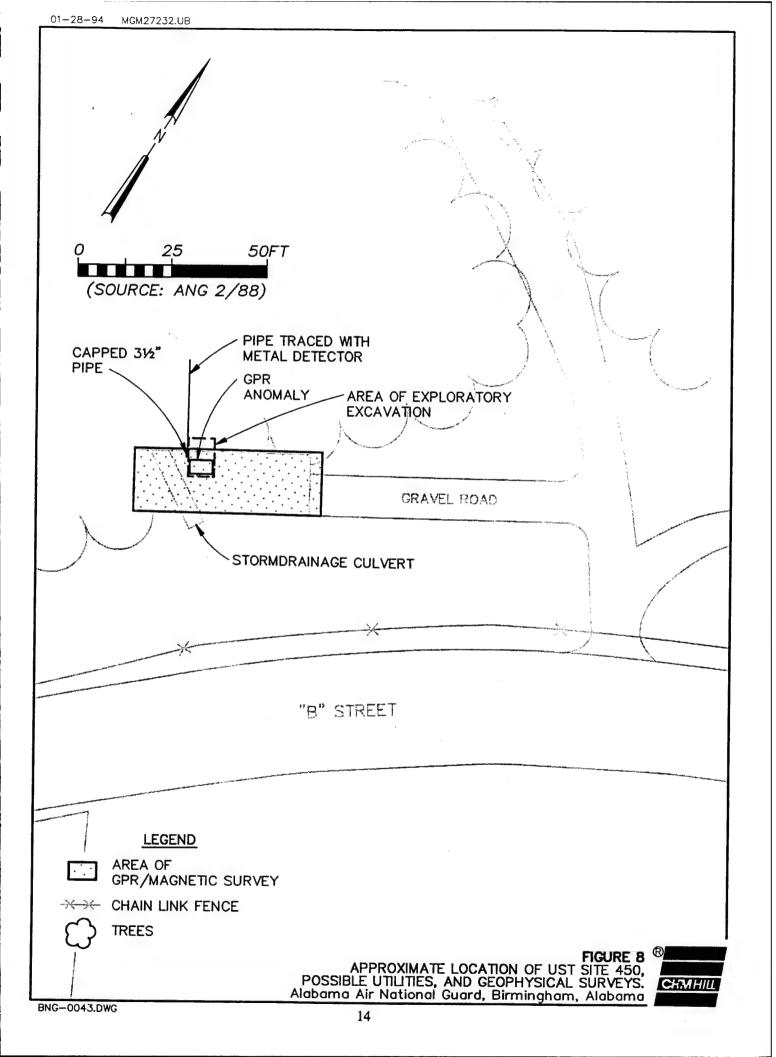
The last area suspected of containing a UST was located northwest of B Street and is shown in Figure 8. A large concrete slab is present there on an unused roadbed. The center of the slab contains a box culvert. A raised 3-inch pipe that was at one time suspected of being a fill pipe located just to the east of the culvert has been removed. The pipe elbowed just below ground surface and ran up the hill. The total length of the pipe was approximately 8 ft in length and was not connected to any other structure. Several pipes of similar size surround this pipe and were cut flush with the concrete slab and filled with concrete. GPR indicated an anomaly east of the culvert near the surface pipes.

On May 18, 1990, an attempt to locate the suspected UST 450 was made. A trench and tunnel were excavated to approximately 7-1/2 feet underneath the pad that, based on the GPR data, indicated the presence of UST 450. The trench and tunnel were more than sufficient to locate the tank if it existed. There was no indication that the tank existed. The soils had no petroleum staining, and HNu readings were 0 ppm.
